EXPERIMENTAL INVESTIGATION OF WIND TURBINE BEARING SUBSURFACE INITIATED DAMAGE

PhD student:
Hamza Al-Tameemi: hahal-tameemi1@Sheffield.ac.uk

Destructive investigation of failed bearing

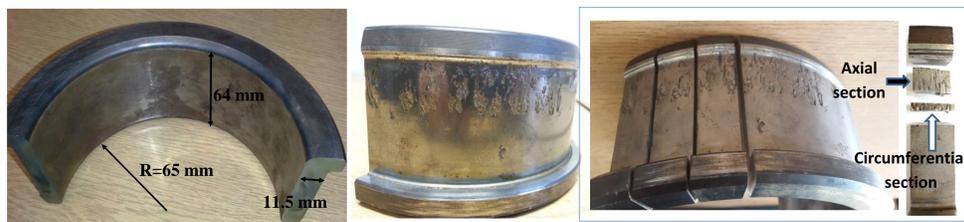
To develop a better understanding of the deterioration of wind turbine bearings during service an examination of a failed bearing is performed. This bearing was used in a planetary stage of wind turbine. It was in service for five years before failure.

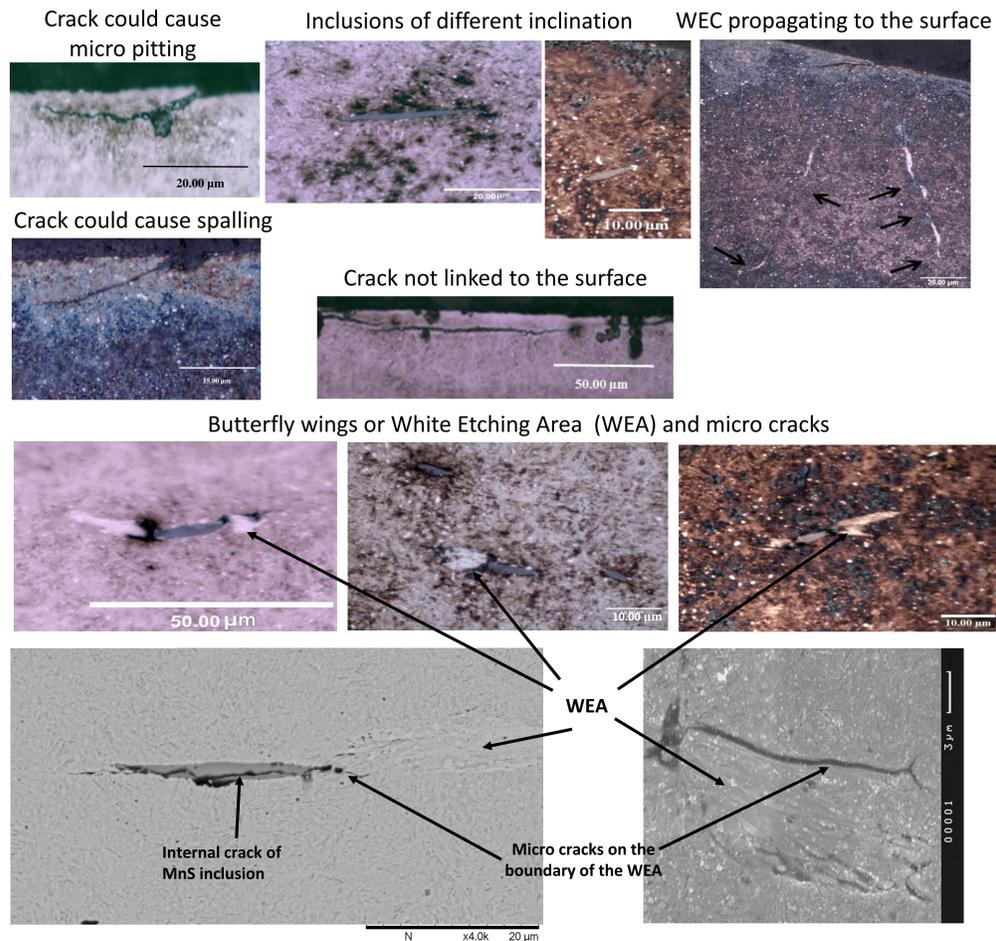
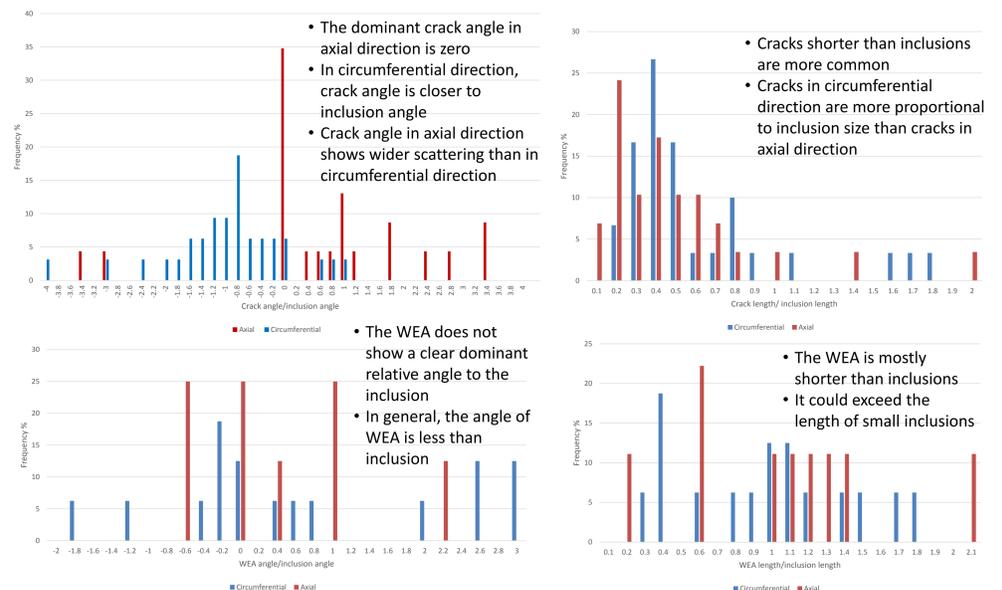
Surface and subsurface features and microstructural damage

Different subsurface forms have been observed such as:

- Inclusions with separation only
- Inclusions with WEA only
- Inclusions with Separation and WEA
- Inclusions with Separation, WEA and micro crack

The depth of different damages could be ranked as:

1. Separation from more than 1000 µm to very close to the surface
2. Micro cracks from about 600 to 50 µm
3. WEA from about 400 to 50 µm
