Progress in Monitoring a Mechanical Drive Train Test Rig

Supergen Theme X Workshop

Energy Group, School of Engineering, Durham University

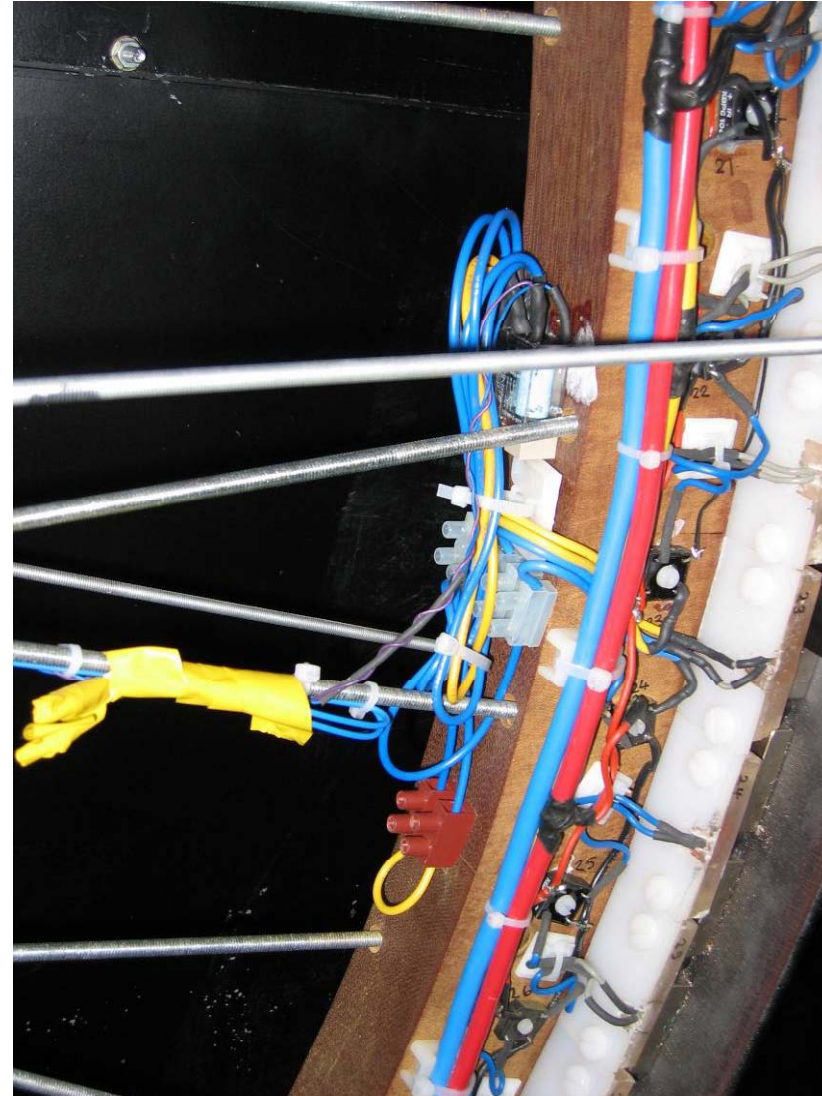
- Shorted Coils
 - 84 coils on the stator
 - Remote relays: one, two or three coils connected normally or shorted.
- Load Conditions
 - Switched load bank
 - Various load conditions have been applied to investigate the operational regime under which the strongest detectability level may be obtained.
- Rotor Unbalance
 - Masses added to the rotor of the generator
- Gearbox Oil
 - Drained to investigate effect on vibration

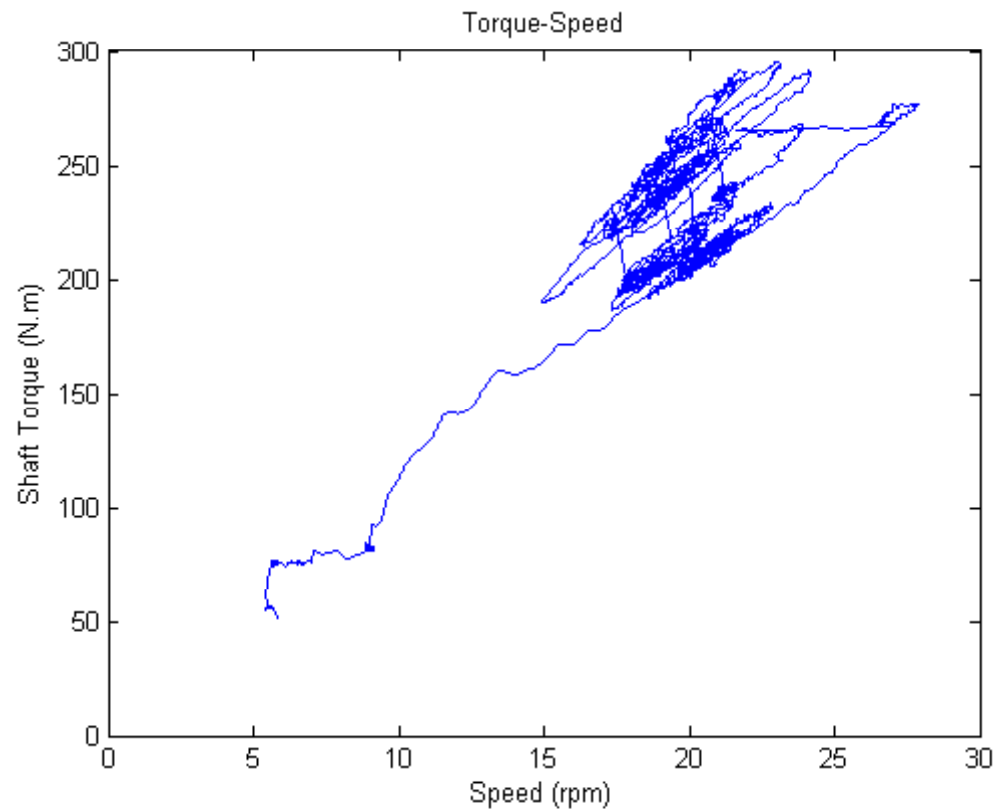
Shorted Coils – Torque-Speed

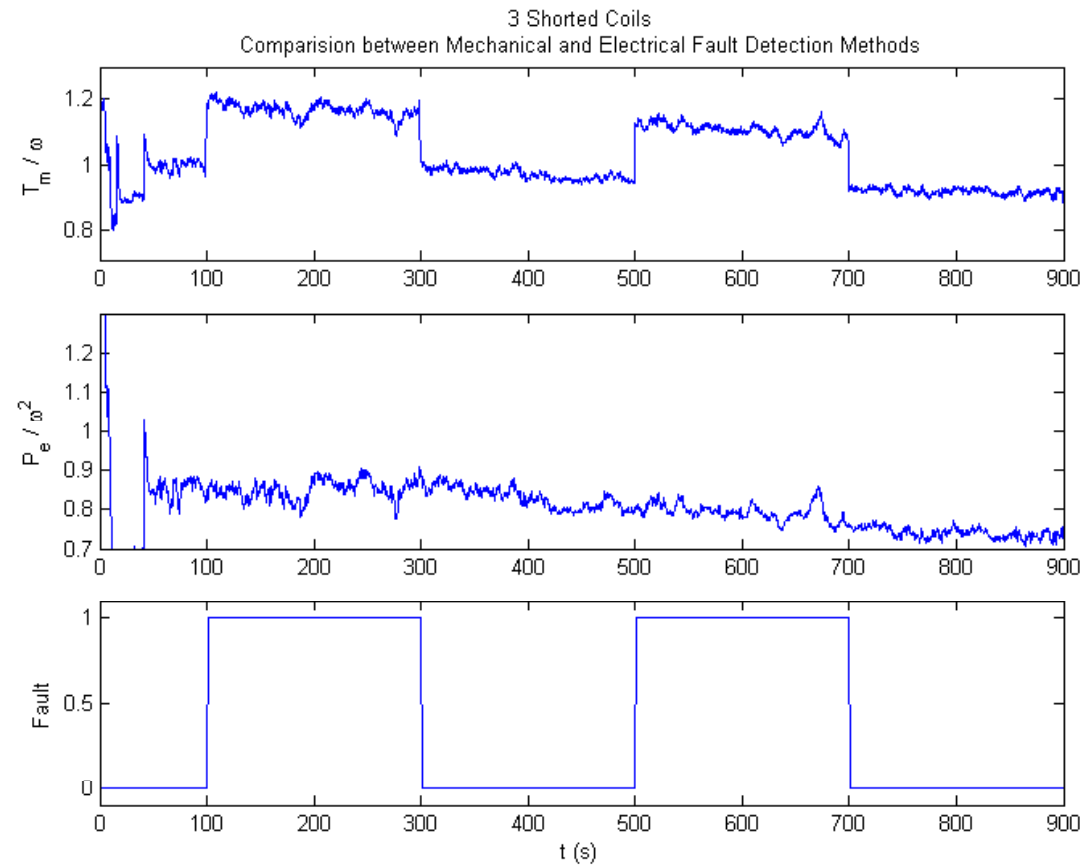
Shorted Coils-Torque/Speed-Detectability

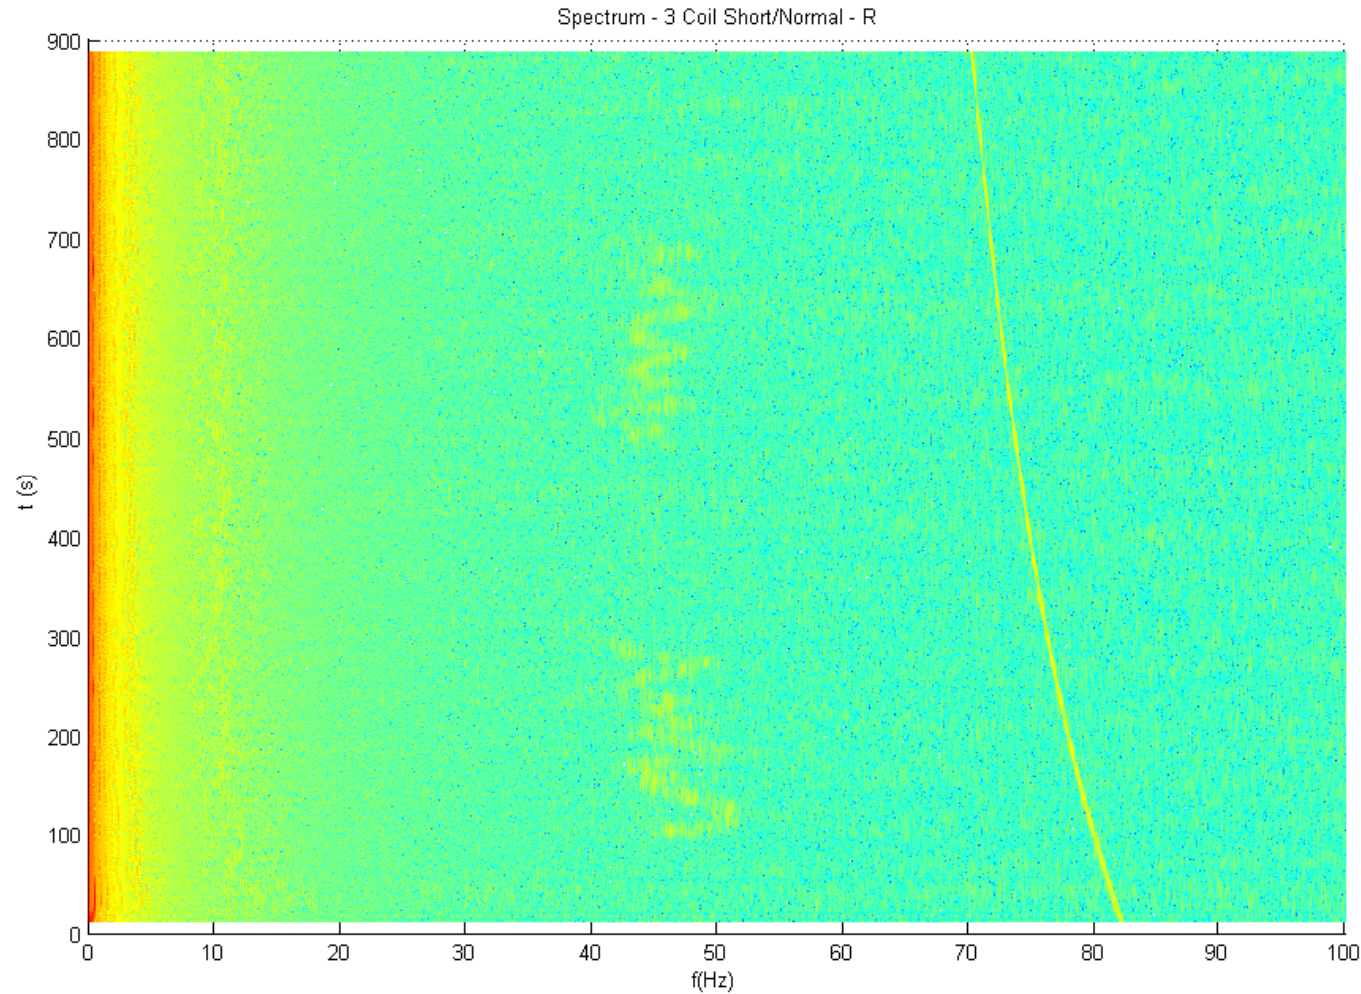
Shorted Coils – Spectral

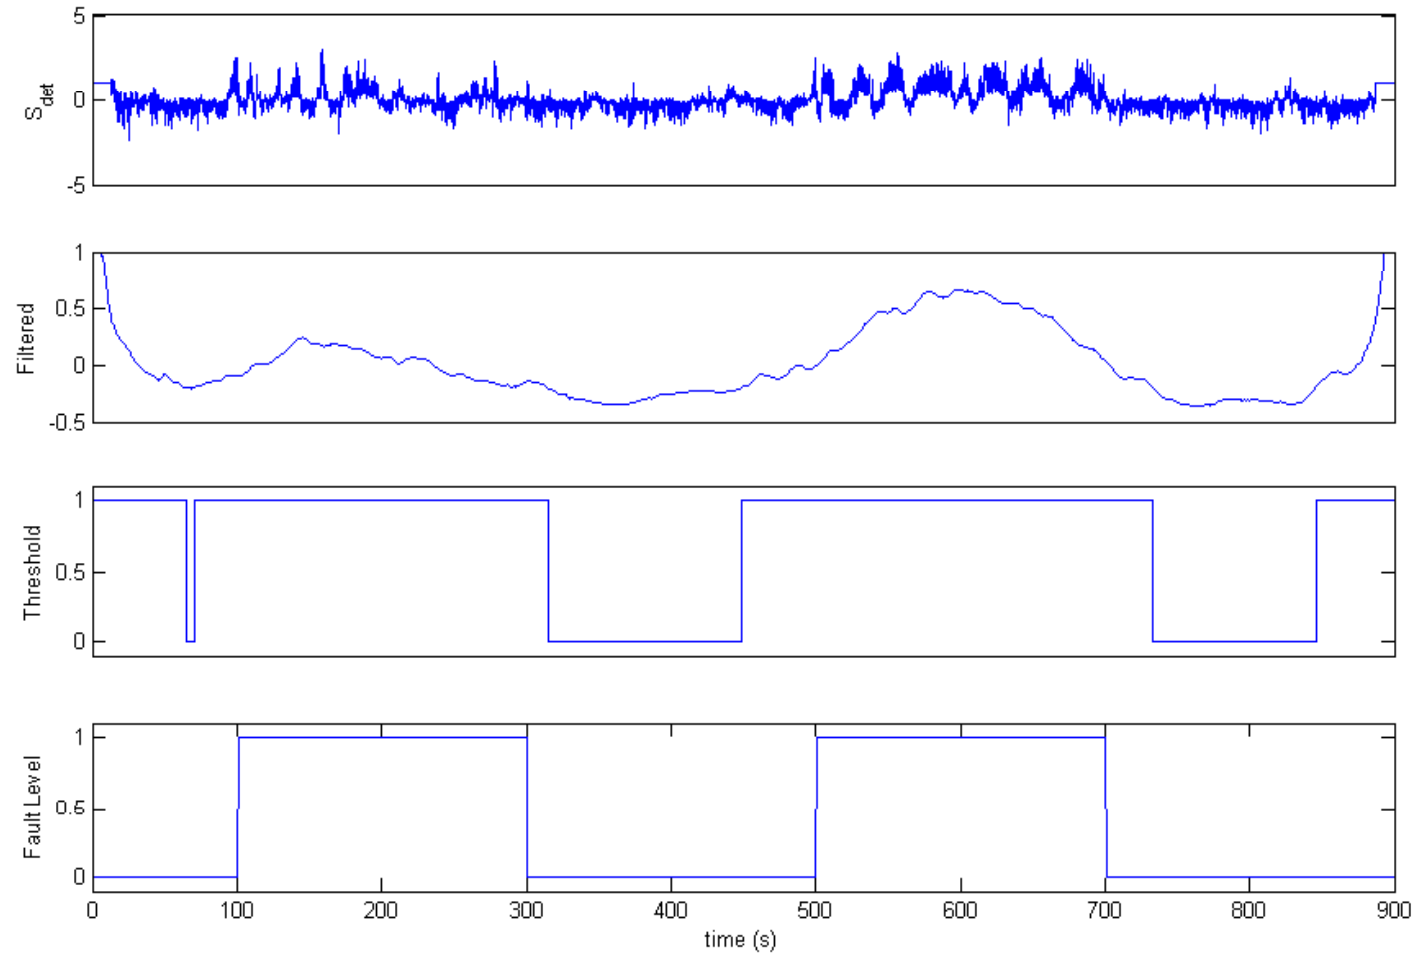
Shorted Coils – Spectral

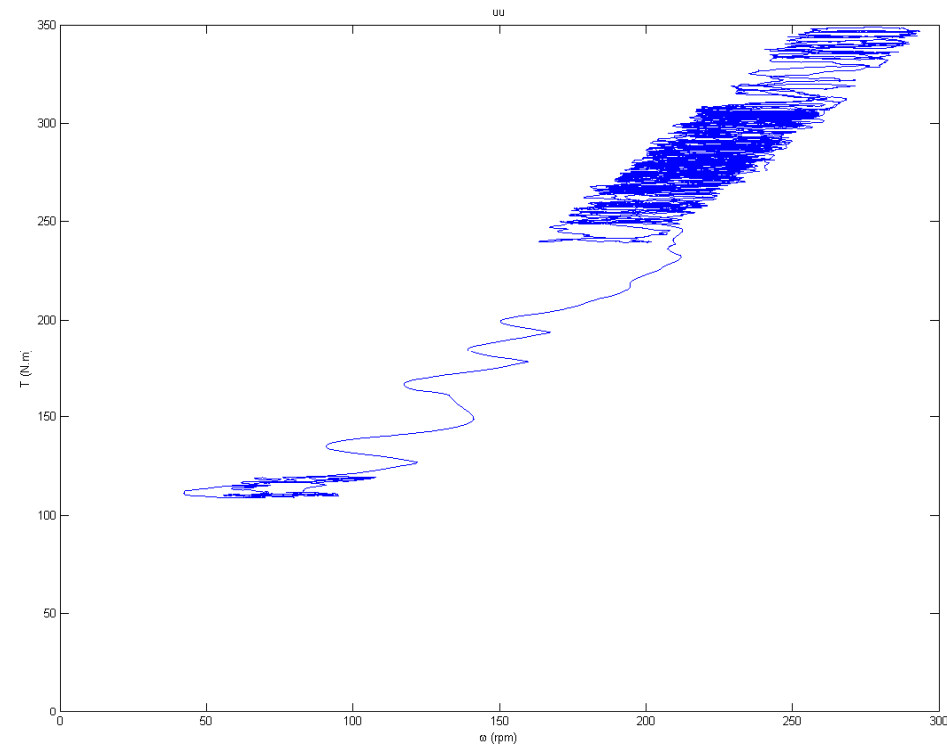
Rotor Mass Unbalance – Torque-Speed

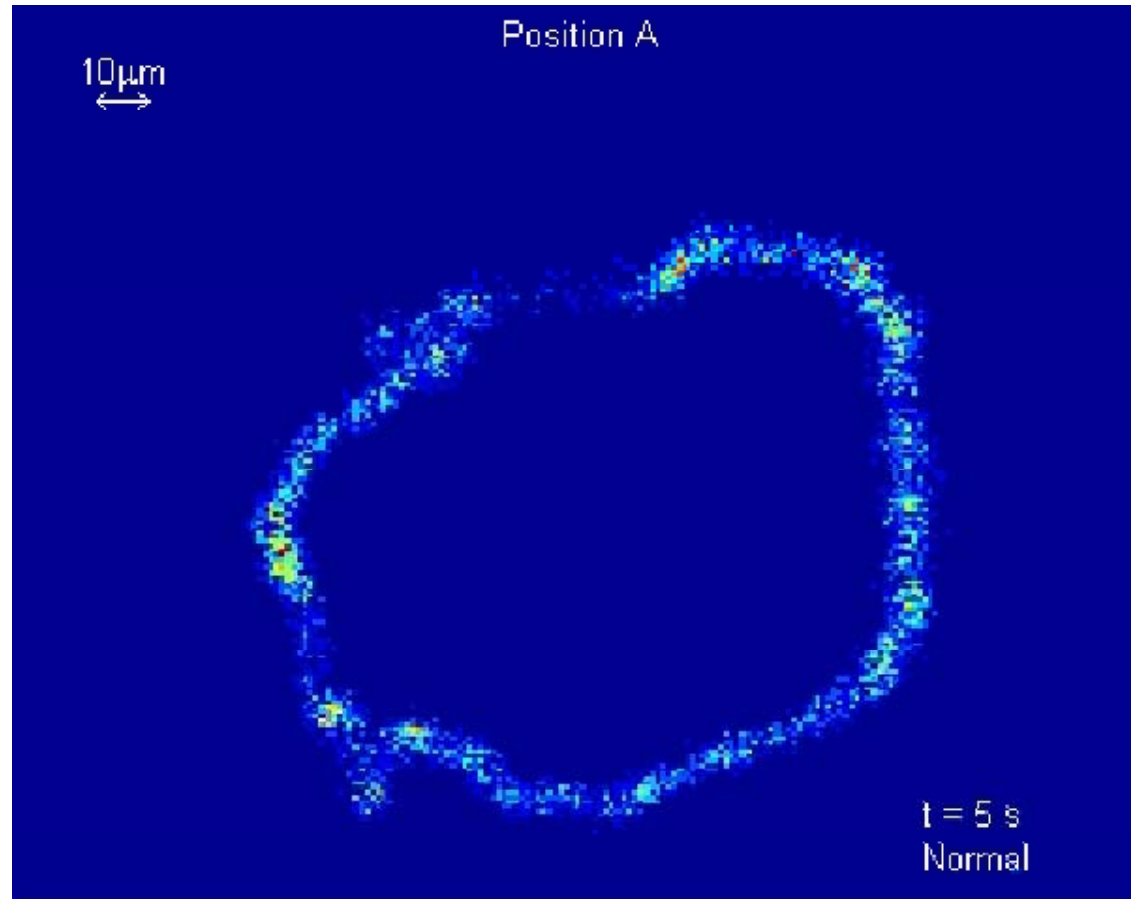
Rotor Mass Unbalance – Displacement

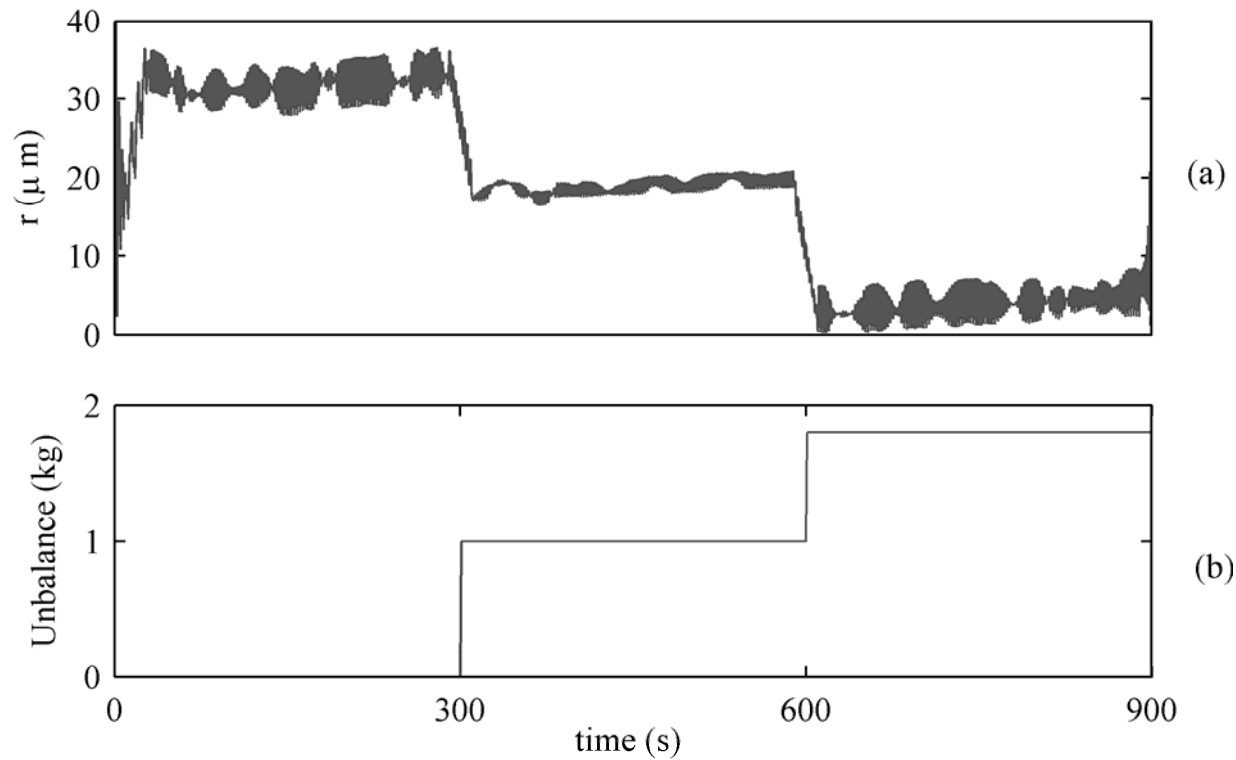
Rotor Mass Unbalance – Displacement

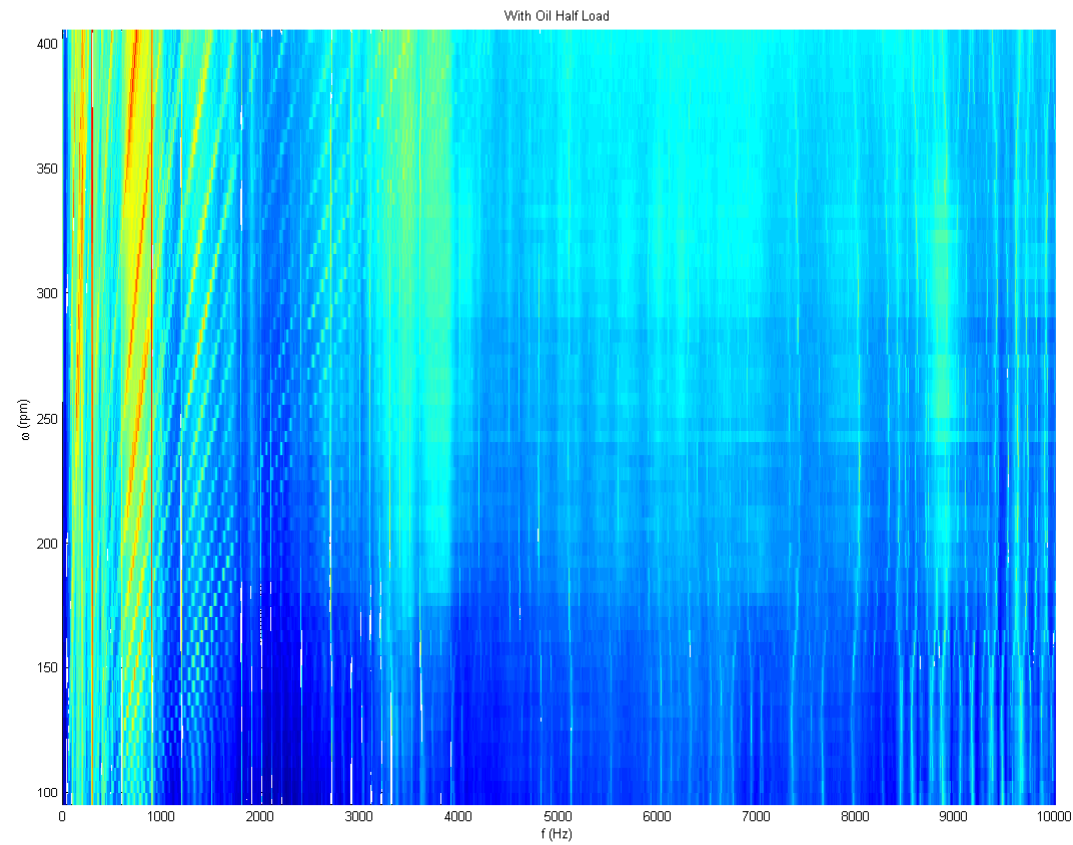
Gearbox Vibration

With Oil

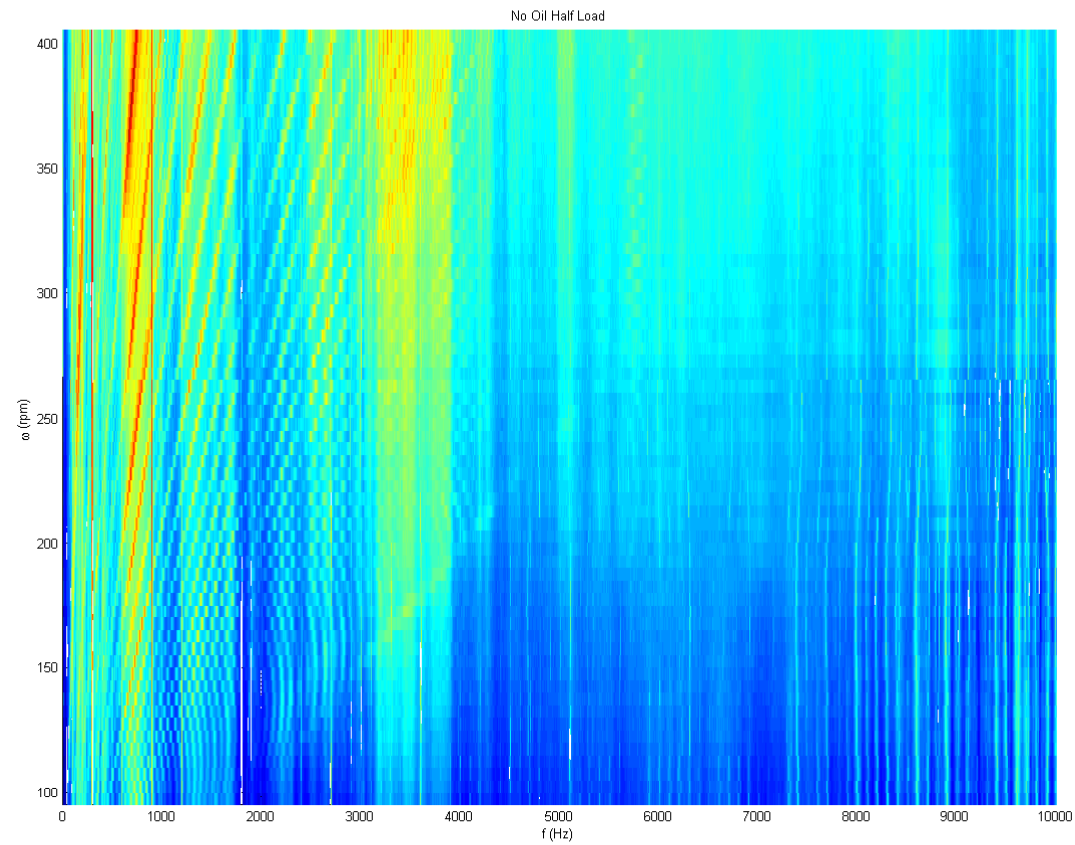
Gearbox Vibration

Without Oil

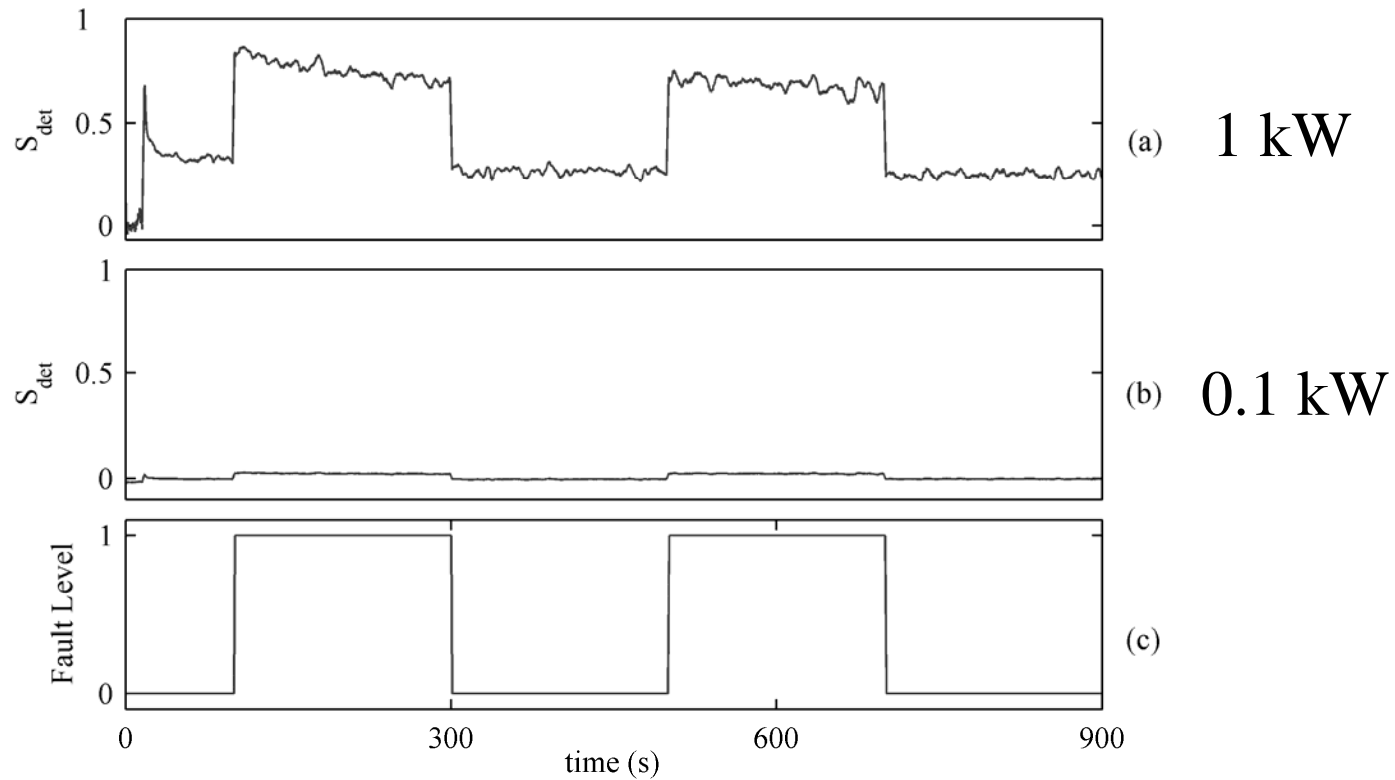
Load Conditions – Shorted Coils
